SERVICE BULLETIN

MANDATORY ACTION REQUIRED

Subject: Chafing of Aileron Cable Assembly P/N 7227151-522WE.

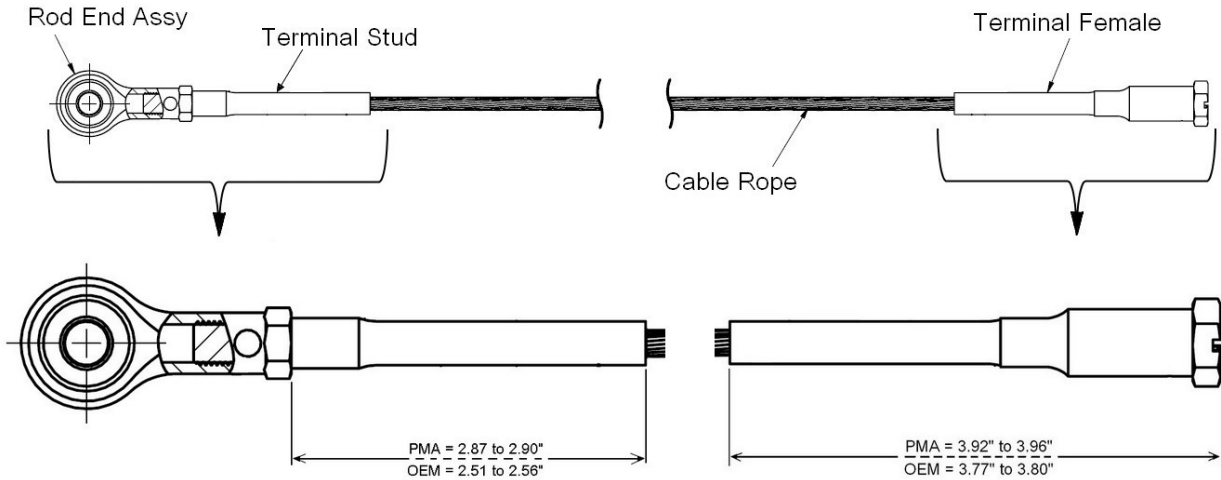
Following the operator's reports of chafing wear damage Wencor developed a method for distinguishing the OEM cables -521 and -522 from the Wencor PMA cables -522WE by measuring the length of the cable terminals as shown below.

Aileron Cable Identification Summary			
	-521	-522	-522WE
Rod End Terminal Length	Shorter *2.51" - 2.56"	Shorter *2.51" - 2.56"	Longer *2.87" - 2.90"
Female Terminal Length	Shorter *3.77" - 3.80"	Shorter *3.77" - 3.80"	Longer *3.92" - 3.96"
