SERVICE INFORMATION LETTER

SIL # 170921-46-3953-1WE

SUBJECT: Part identification label placed on the wrong part surface.

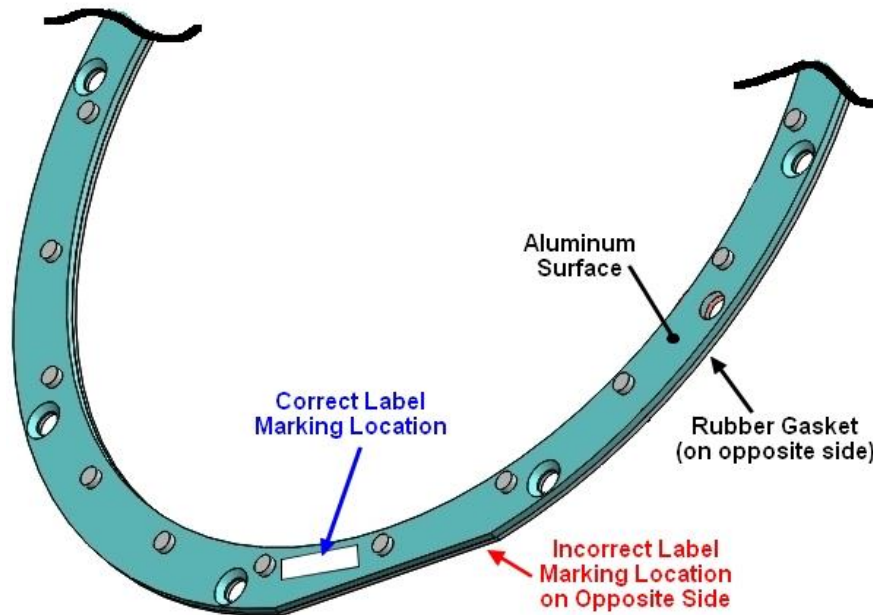
The Retainer Assembly was mislabeled where the small part identification label was placed on the rubber gasket side of the part as shown below in Figure 1. The correct location for the identification label is on the aluminum side of the part.

Figure 1, Partial View of Retainer Assy Showing Incorrect Marking Label Location

The condition described above does not affect aircraft safety because the size of the label is not large enough that it would appreciably affect the sealing of outside elements. In addition, there are two Retractable Landing Light Assemblies and an additional landing light located on the nose landing gear on each aircraft. Therefore there is sufficient lighting redundancy such that a single failure of the Light Assembly would not affect aircraft safety.

Any Wencor Retainer Assembly, PN 46-3953-1WE, purchased before the date of this SIL that has not been installed, may be returned to Wencor for replacement per section 4 of this SIL at the discretion of the customer.

Any Wencor Retainer Assembly that has been installed into the NHA and passed the required CMM testing may remain in service at the discretion of the end user without appreciable risk to normal aircraft operation.

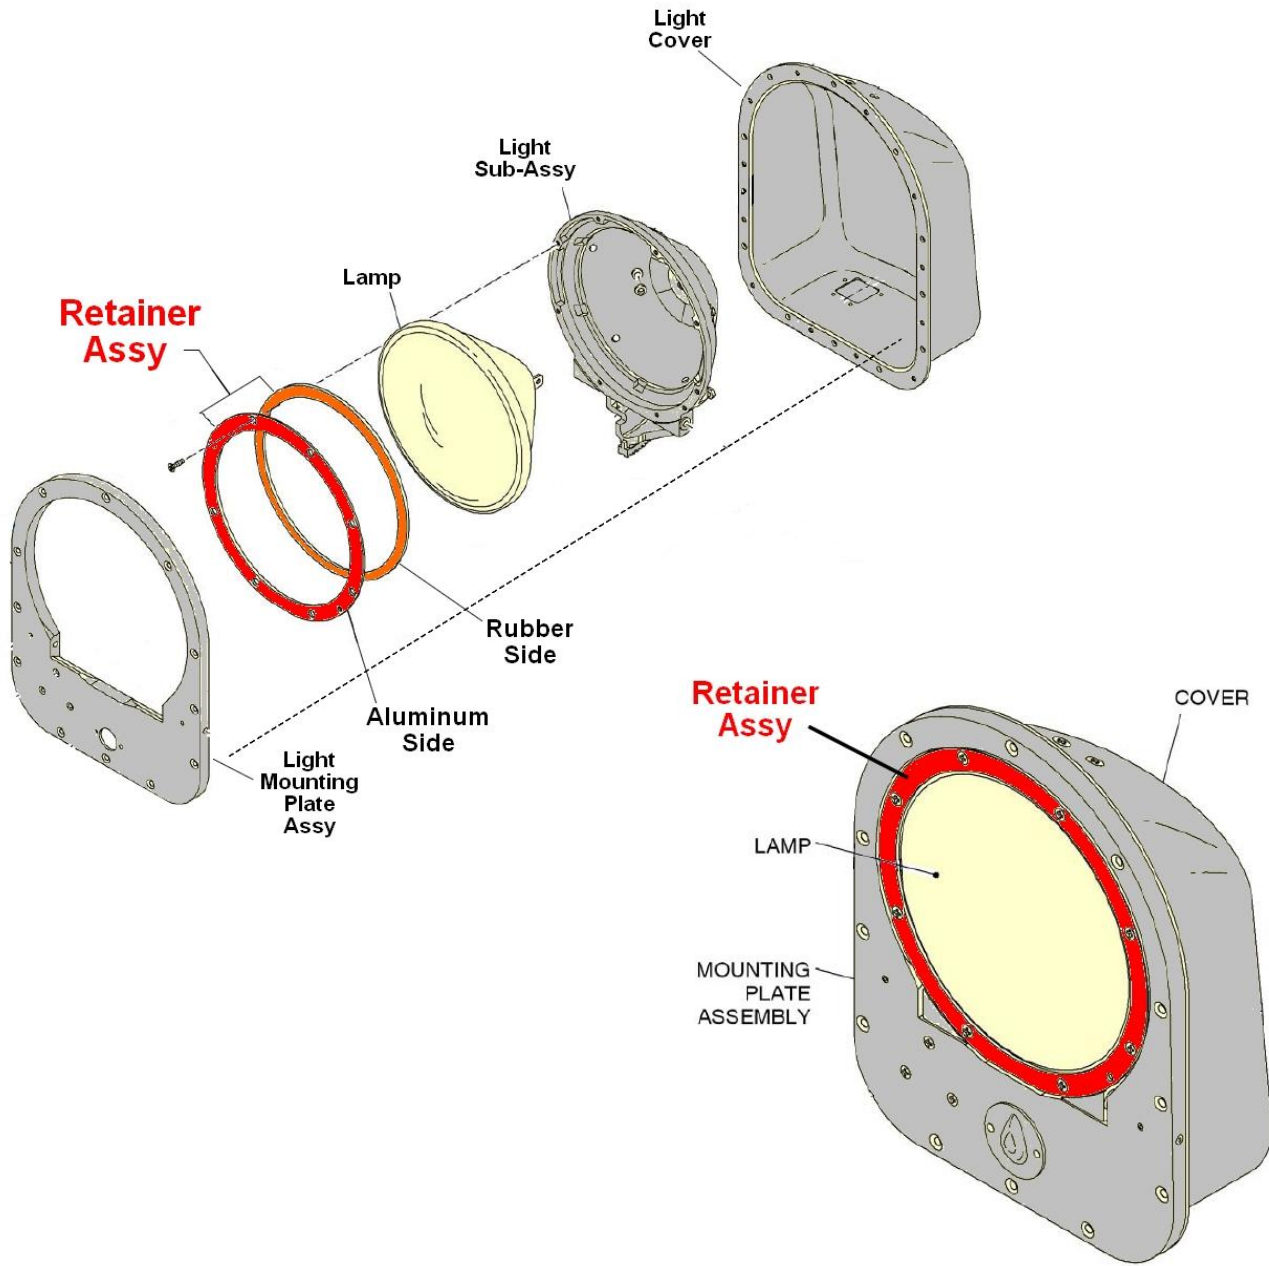
The Retainer Assy is used to attach and retain the lamp in the Retractable Landing Light Assembly as shown in Figure 2. There are two Retractable Landing Light Assemblies on each aircraft, one on the underside of each wing tip. The rubber gasket located on one side of the Retainer Assy performs a sealing function to prevent outside elements or contaminants from contacting the areas of the lamp located behind the gasket. The lamp itself is a fully sealed light, with the only possible exposure from outside elements located at the rear electrical connector.

Figure 2, Installed Location of the Retainer Assy in the Retractable Landing Light Assy
