# SERVICE INFORMATION LETTER

SIL # 171017-23072-1400WE

**SUBJECT:** The outer diameter of the heat shrink tubing on the Speed Pickup is too large and causes difficulty during installation into the NHA.

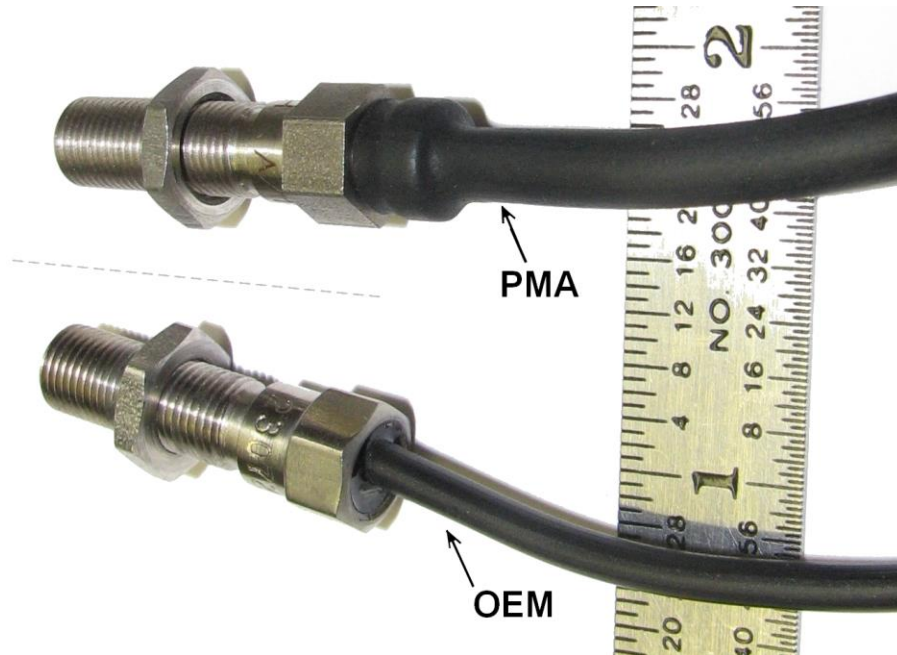
**Figure 1**, Side-by-Side Image of Speed Pickup Showing Heat Shrink Tubing

Some customers have complained that the OD size of the heat shrink tubing is causing difficulty installing the Wencor Speed Pickup. The OD size of the Wencor Speed Pickup is approximately 0.175", while the OD size of the OEM is only approximately 0.115". The Speed Pickup wires that are covered by heat shrink tubing must pass through a grommet when installed on the NHA DC Starter-Generator as shown in Figure 3. The larger size heat shrink is more difficult to pass through the grommet.

Any Wencor Speed Pickup Assemblies that are currently uninstalled that have been purchased prior to the date of this SIL may be returned to Wencor for replacement at the discretion of the end user.

However, any Wencor Speed Pickup Assemblies that are currently installed into the NHA, passed the required CMM testing for the NHA and are in service, may remain in service at the discretion of the end user with no risk to normal operation.
