SERVICE INFORMATION LETTER

Subject: Loss of Electrical Continuity on Wencor Plug Assembly

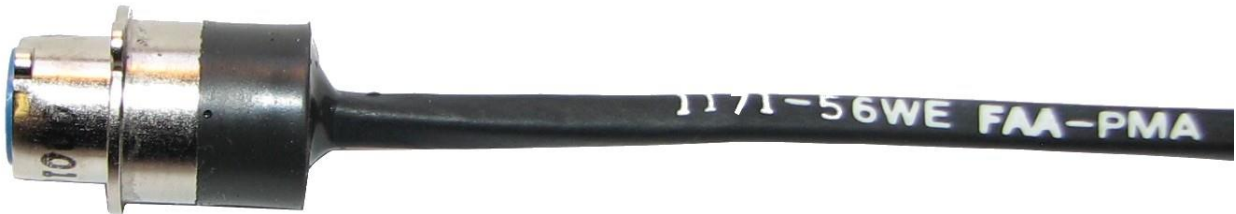
Figure 1: Wencor Plug Assembly PN 1171-56WE

Loss of electrical continuity at the Plug Assembly connector due to wire breakage from over-crimping during manufacturing.

Upon examination of the discrepant parts, a broken wire was found at the crimp connection between the wire and pin. The cause of the broken wire appears to be random over-crimping during manufacturing of the PMA Plug Assembly. Over-crimping caused a weakening of the wire at the crimp location, reducing the wire's tensile strength.

Every Plug Assembly produced by Wencor is tested for continuity during the manufacturing process and all the Plug Assemblies passed this test; however, as the leads were bent during installation to fit the Plug Assembly into the NHA actuator housing, tension on the crimp connection caused the wire to break.

Any end user of the Wencor Plug Assembly that has already installed the PMA part and passed the NHA test requirements as defined in the OEM CMM may remain in service without any change in aircraft safety. However, any operator that discovers a failed Wencor Plug Assembly should return it to Wencor for replacement per the Wencor warranty agreement.

End users who have Wencor Plug Assemblies in their stock which have not yet been installed may, at their discretion, return the PMA part for a replacement of a Plug Assembly which has been manufactured using a more controlled crimping process to prevent over-crimping.
